# TO RAISE A TELL AND RAISE IT WELL: SOME ODD REGULARITIES OF THE EARLY CHALCOLITHIC CONSTRUCTION TECHNIQUES AND THE BUILDING STRATEGIES AT TELL PETKO KARAVELOVO

Alexander Chohadzhiev<sup>1</sup>

## Abstract

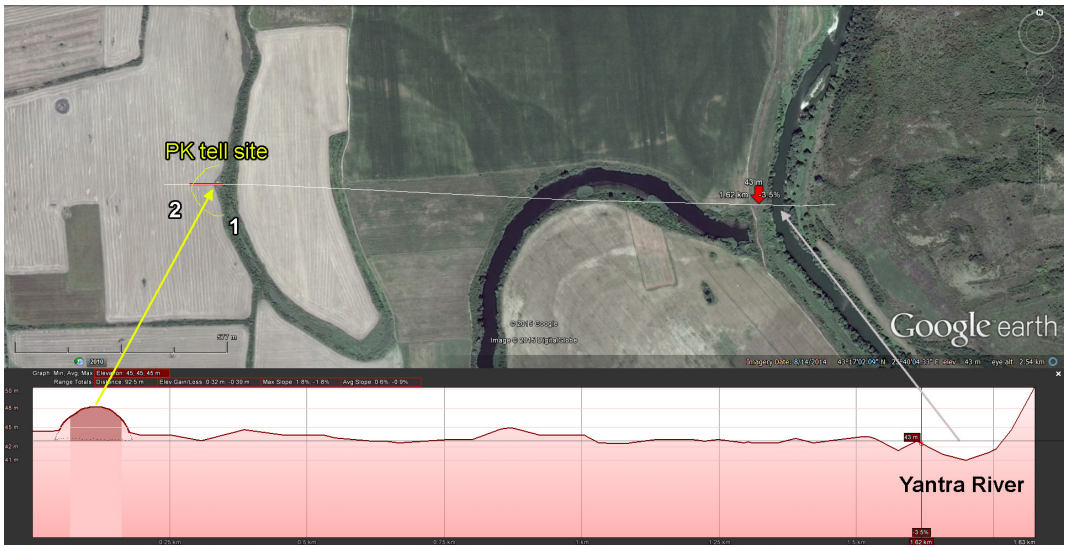
Figure 4. Satellite image of PK vicinity, with a section between the modern river bed and the tell: (1) wetland overgrown with low vegetation; (2) cultivated field (source: Google Earth).

The archaeological site had an unfortunate fate. The entire eastern half of the tell was destroyed during the construction of dykes and is now wetlands overgrown with low vegetation (fig. 4, see the areas numbered as 1). Through the highest part of the tell, a farming dirt road was made that was recently abandoned but heavy machinery has moved on it for decades (fig. 5). The western half was cultivated intensively for half a century (fig. 4, see the areas numbered as 2), and in 1972, an irrigation pipe was dug into the tell (figs. 8 and 16) intersecting the entire area B from south to north.

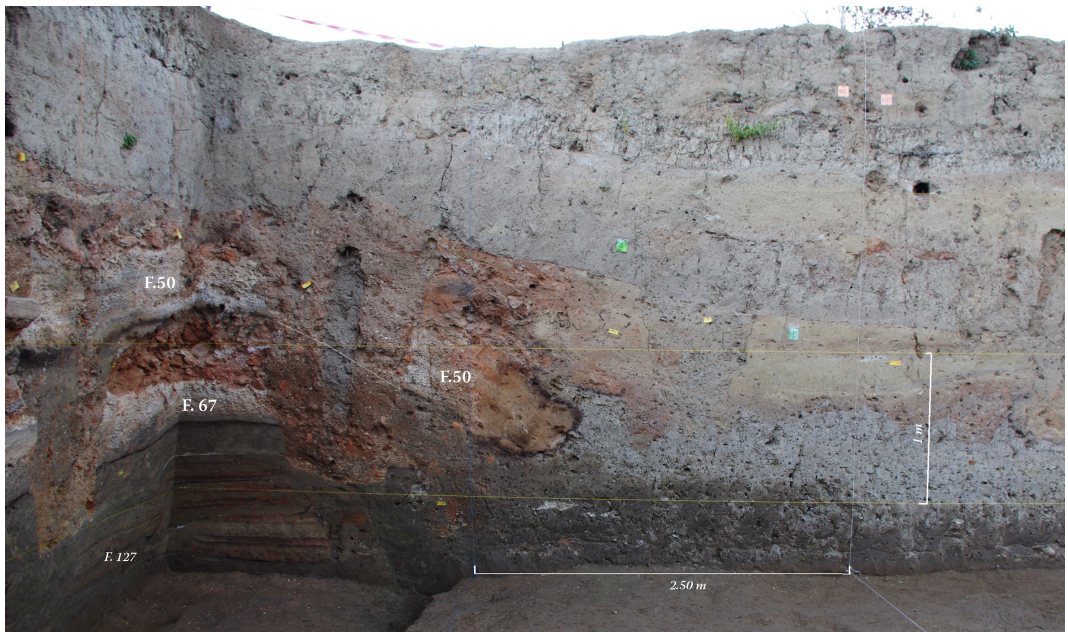
*Figure 11. Area A (2012), northwest corner.*

Feature 67 is at least 12 m long; its northern side is not yet recorded as it lies out of the excavated area. According to the observations at the northern profile, the length of this house exceeds 13 m; this measure will be used for the calculations. The width of the structure is about 7 m (more likely about 7.5 m but the long side walls were completely destroyed and overlapped by the foundation trenches of the upper house; figs. 8 and 11).

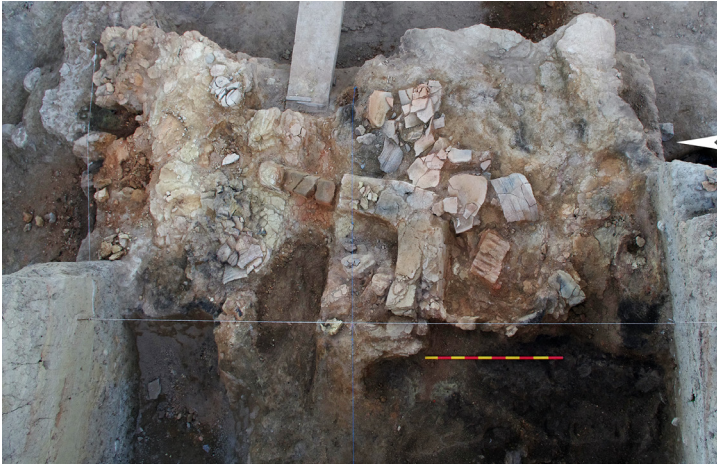
*Figure 14. Burnt upper layer of feature 72 in area A, 2012.*

The upper layer of the debris of the three buildings was burnt at the highest temperatures. It is almost red in color and has an average thickness of 30 cm. This layer includes the entire house inventory (figs. 14–16) and is considered to have been the upper (second), residential floor of the house.

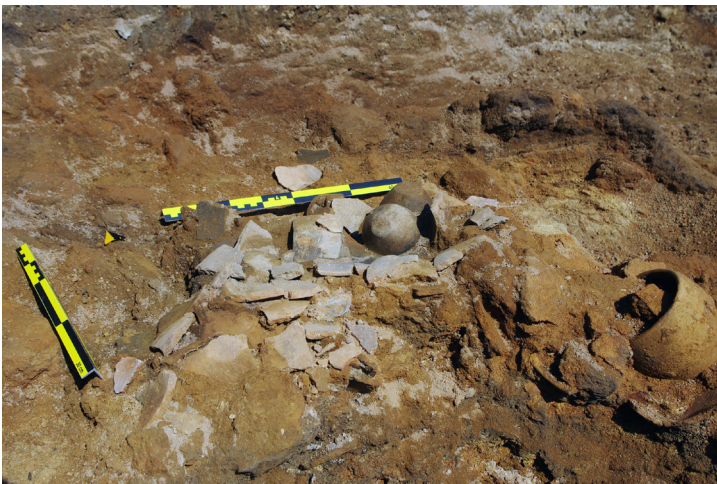
*Figure 15. Burnt upper layer and inventory of feature 67 in Area B, 2014.*

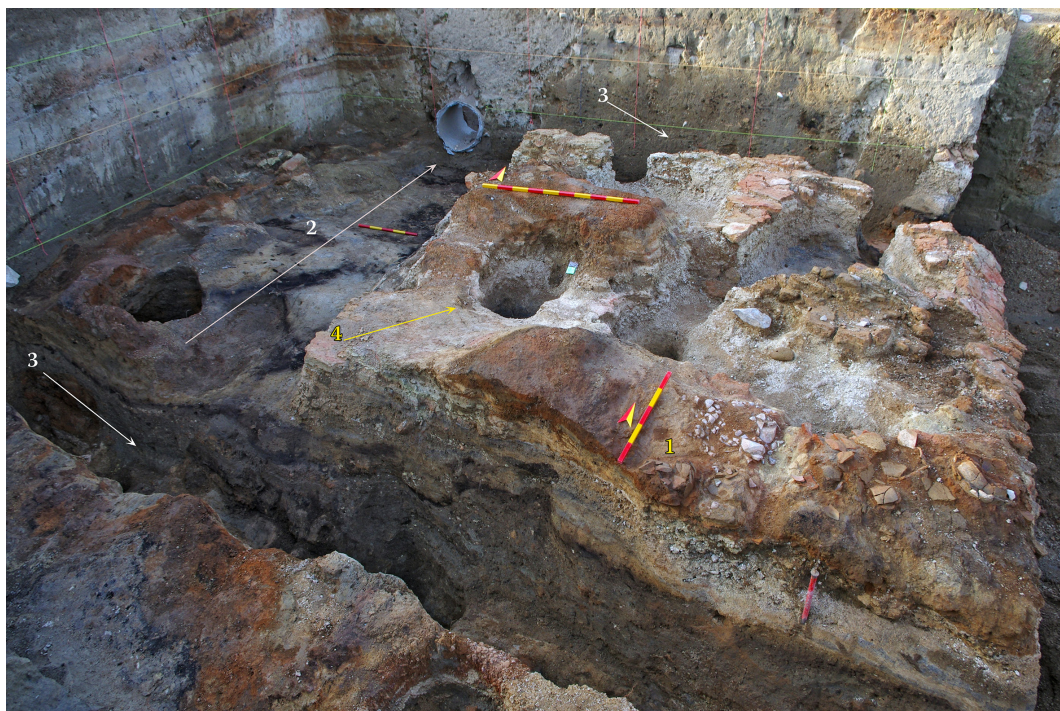
*Figure 16. Burnt upper layer of feature 50 in area B, 2014: (1) preserved inventory in the house; (2) recent disturbance, irrigation pipe ditch; (3) later Chalcolithic foundation trenches; (4) later Chalcolithic disturbances.*

<sup>1</sup> The late Chalcolithic foundation trenches are much deeper than the earlier ones (fig. 16, note the parts labeled as 3), which is logical as it corresponds to the described changes in building strategies (Boyadzhiev 2013, 80).

<sup>1</sup> It is noteworthy that the western periphery of feature 50 and part of its foundation trench was partially destroyed by the irrigation pipe ditch and by later Chalcolithic trenches and pits (fig. 16).

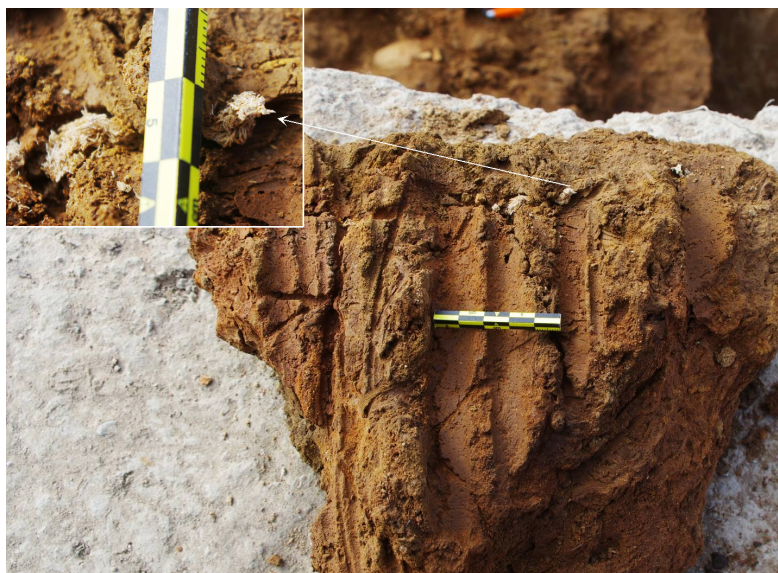
*Figure 17. Burnt wall fragment with imprints of rods tied with ropes. Detail: preserved rope piece. Upper layer of feature 67 in area B, 2014.*

The rods were tied together with ropes, forming panels that were later covered with clay (daub). A piece of such burnt rope was found that was most likely made of linen. Another construction technique was identified at the short walls of the houses: vertical rectangular planks (20 or 30 cm wide) fixed together by tiny sticks and ropes, and then covered with daub. This technique is very well recorded at the southern wall of the upper floor of feature 72 (fig. 18), where numerous pieces of wall-paintings were unearthed as well. Other houses also yielded clues for wall paintings, but they were more abundant and comparatively well preserved in feature 72. The smooth final plastering of the walls in preparation of the painting is very impressive. Most of the wall-paintings display geometric patterns, but there is one piece that seems to depict a tall house (fig. 19.1). Of

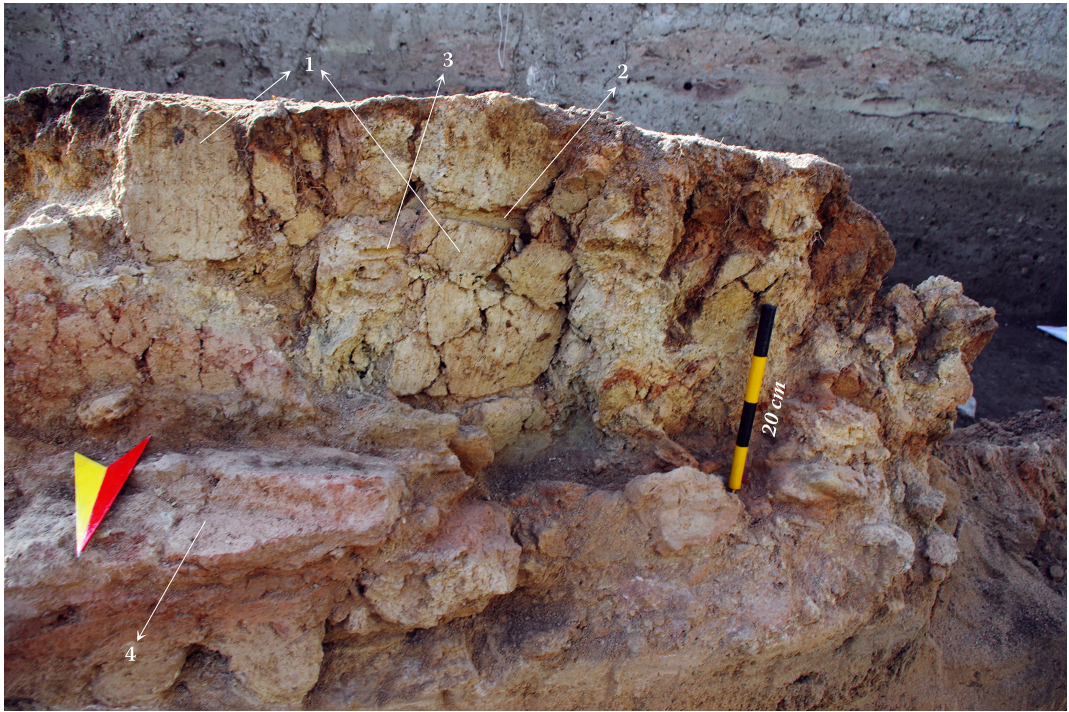
*Figure 18. Preserved middle part of the south wall of feature 72 in area A, 2012: (1) vertical plank imprints; (2) horizontal rod imprint; (3) horizontal rope imprint; (4) the platform.*

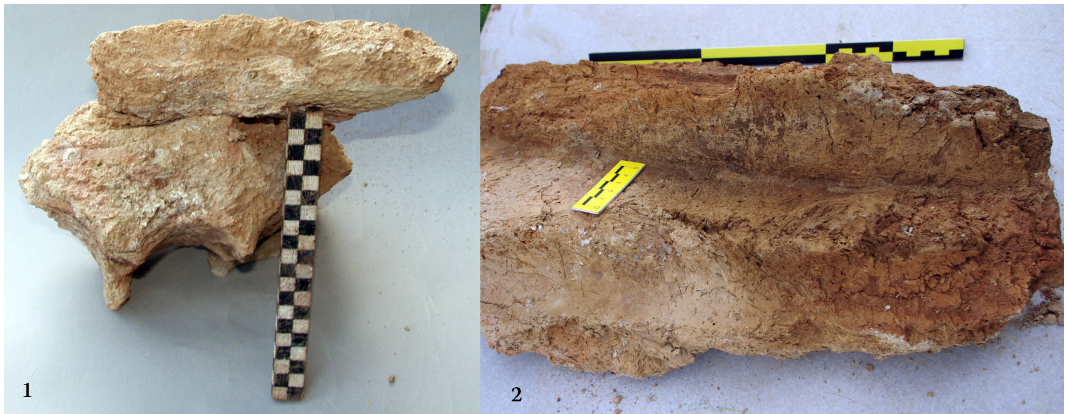
*Figure 20. Burnt fragments of the platform: (1) feature 72, 2003; (2) feature 67, 2014.*

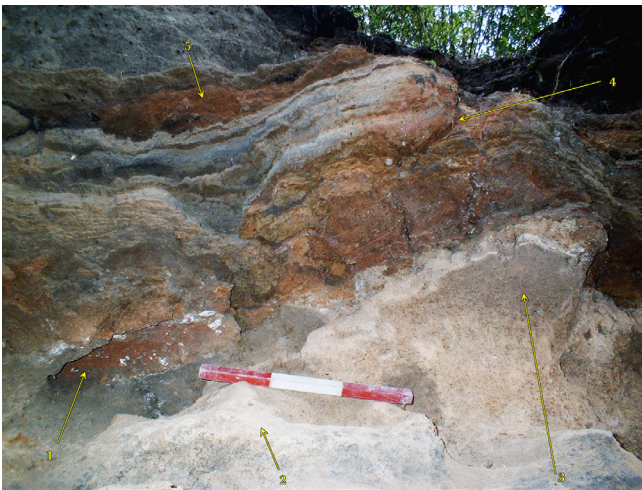
**Figure 21.** Detail of the platform of feature 72, 2003: (1) wood imprint; (2) white grainy layer; (3) white chalky plaster of platform's lower side; (4) clay plasters of the platform; (5) upper burnt layer.

The second common element is the so called ‘platform’: a dense mass of clay with imprints of rods tightly fitted next to each other on the lower side (fig. 21, note the arrow

numbered as 1). The platform has two parts: the core, *i.e.* the timber plastered from above with clay, and the heavy layer of multiple thin plasters (fig. 21, note the arrow numbered as 4). In house 1, there are 35 plaster layers, while in the other two structures the number of layers is between 25–27. The wooden part of the construction contains both 10–18 cm long rods with a round section (fig. 20.1) and beams (planks) with a rectangular section (fig. 20.2) up to 20–25 cm wide. The average weight of a square meter from this part of the house is ca. 86 kg (daub only) which means that the entire platform between the two stories weighted more than 10 tons including lumber. Such a weight seems stunning for a non-grounded structure, but feature 72 offered an important clue for the ‘multiple story’ theory. At some places, smooth white daub was found, chalky and heavy, covering the bottom part of the timber (fig. 21, note the arrow numbered as 3). The core is usually burnt much stronger than the part with plasters. This fact can be explained either by the abundance of oxygen from below or by a sort of ‘air tube effect’, providing air after the lumber had been consumed by the fire (Gheorghiu 2006, 158). I must emphasize here that the core of the platform is the element of the houses that yielded evidence of a higher average temperature of burning (only the ‘hot-spots’ discussed below show higher temperatures, but they are not structural elements). There is much evidence of preserved charred timber from the burnt houses, but not a single case from a platform. The color of

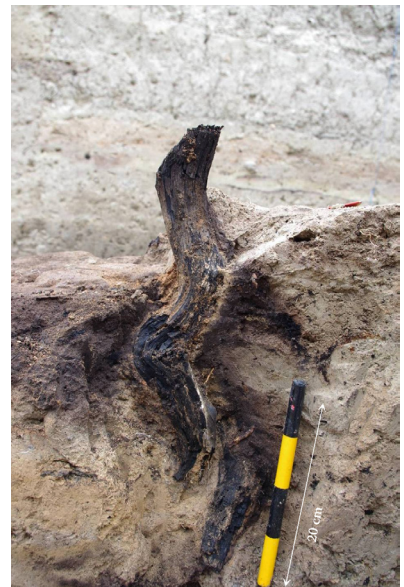
**Figure 22.** Detail of a curved stake that links the walls of the two floors. Feature 72 in area A, 2012.

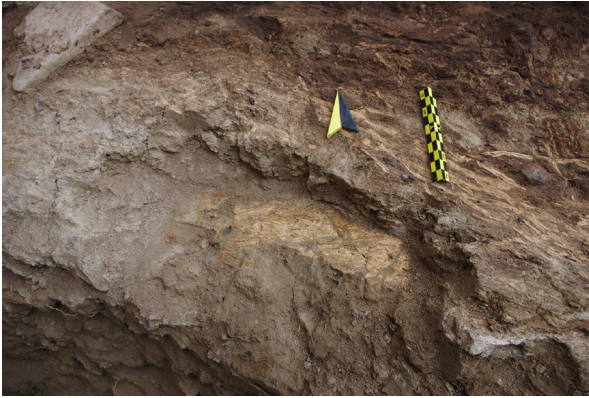
*Figure 23. Detail of organic 'patchworks' (mats) incorporated in the earthen walls. Feature 67 in area B, 2015.*

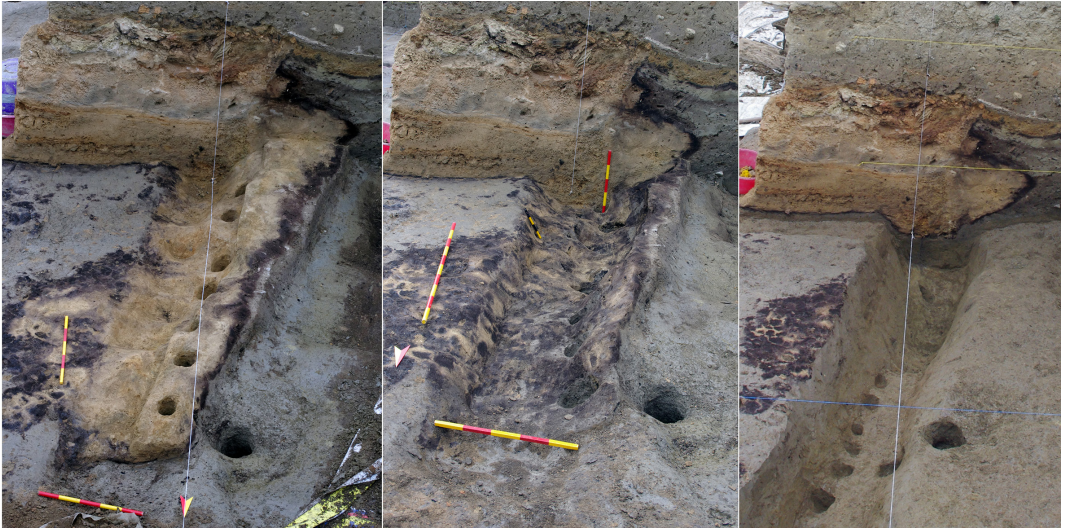
*Figure 26. Three stages of excavation of the west part of feature 72 in area A, 2012.*

The outer wooden paneling of the walls of feature 72 is preserved; it was made of narrow horizontal planks (fig. 24, note the parts labeled as 2). This explains the presence of the black streak around houses, and not only on the floors. The rammed earth walls were grounded by wood, too; the fire and the humid environment that followed it turned the wooden flooring, the foundations of the walls, and the outer ‘paneling’ into a continuous black line. It outlines the debris of every burnt structure, almost without exception. This is a trustworthy indicator that the destruction of a certain structure, from top to bottom, was a single event (fig. 26).

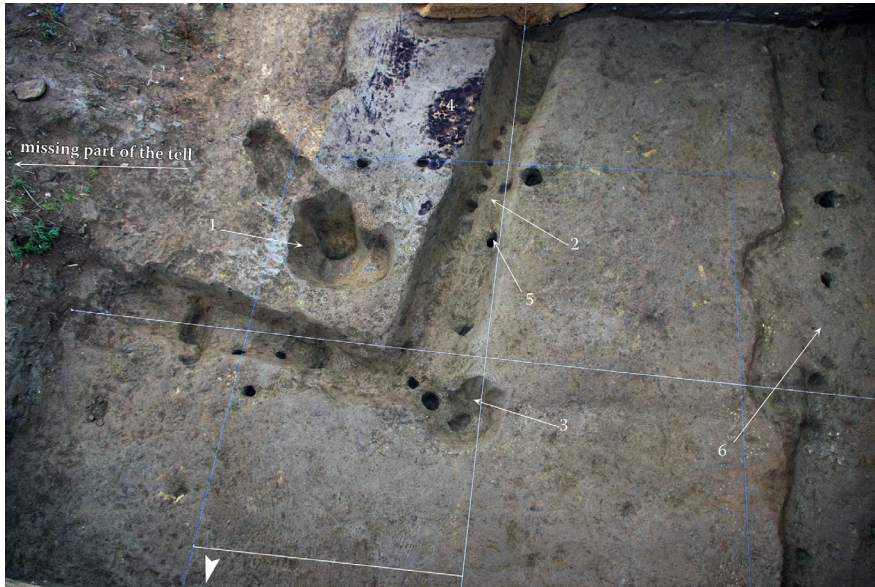
*Figure 27. Northwest part of the foundation trench of feature 72 in area A, 2012: (1) inner pits of free supports; (2) smaller postholes in the inner part of the trench; (3) corner enlargement; (4) horizontal remains of the black streak; (5) bigger postholes in the outer wall of the trench; (6) foundation trenches of features 67 and 127.*

pillars, the central one being situated along the central long axis of the building, with the pillars being at about two meters from each other. Both side rows are at about two meters from the respective long walls. Such a distribution makes the lower level uninhabitable but firmly secures the entire platform construction. The rough calculations suggest that every four square meters of the second level (together with the platform) were supported by either four columns or two columns and the wall, and the unsupported distance never exceeds two meters in both directions. The other two houses yielded less explicit evidence of similar supporting systems (fig. 27, note the part numbered as 1; fig 29.2).

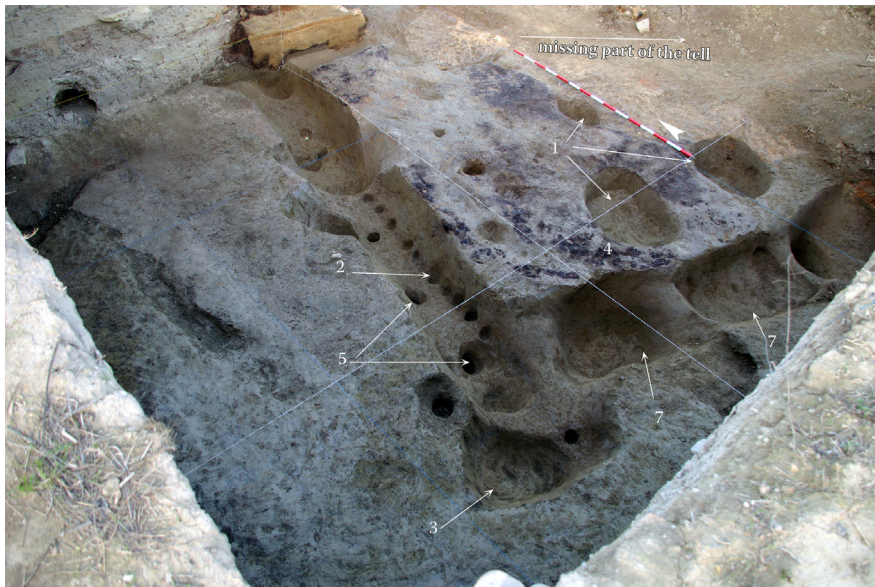
*Figure 28. Southwest part of the foundation trench of feature 72 in area A, 2012: (1) inner pits of free supports; (2) smaller postholes in the inner part of the trench; (3) corner enlargement; (4) horizontal remains of the black streak; (5) bigger postholes in the outer wall of the trench; (7) large pits within the south trench.*

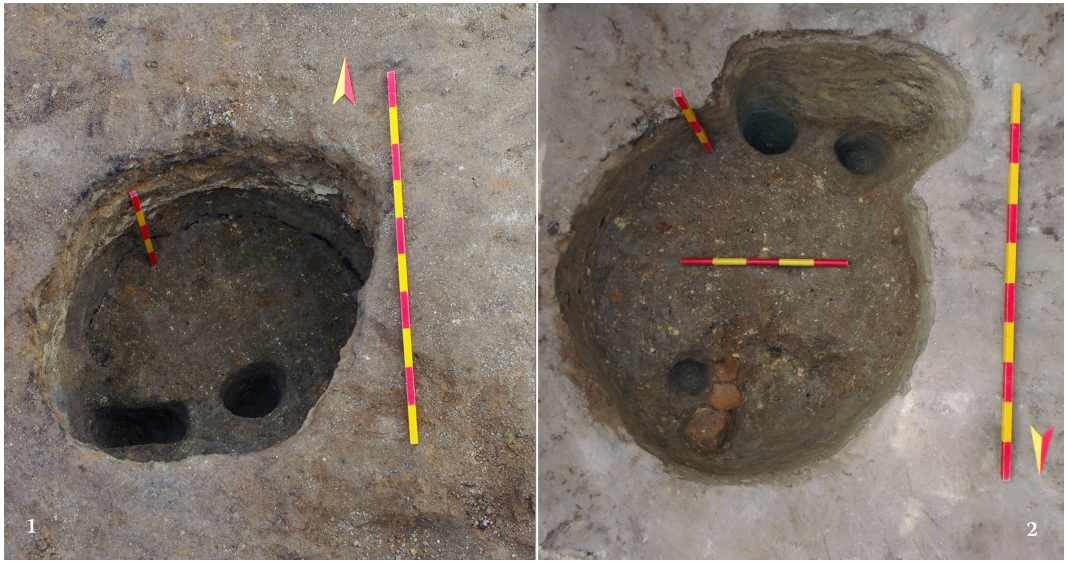
*Figure 29. Evidence of pits for multiple posts: (1) feature 119, pit for two free supports from the construction of feature 50 penetrating the debris of feature 67 in area B, 2014; (2) feature 116, pit for three free supports from the construction of feature 67 penetrating the debris of feature 127 in area B, 2015.*

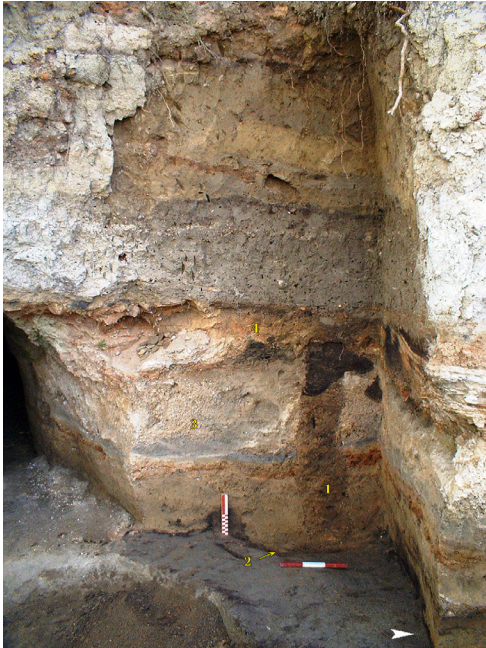
**Figure 30.** Evidence of free supporting pillar, feature 72 in area A, 2004: (1) posthole; (2) the pit in the sterile ground; (3) white grainy layer; (4) platform.

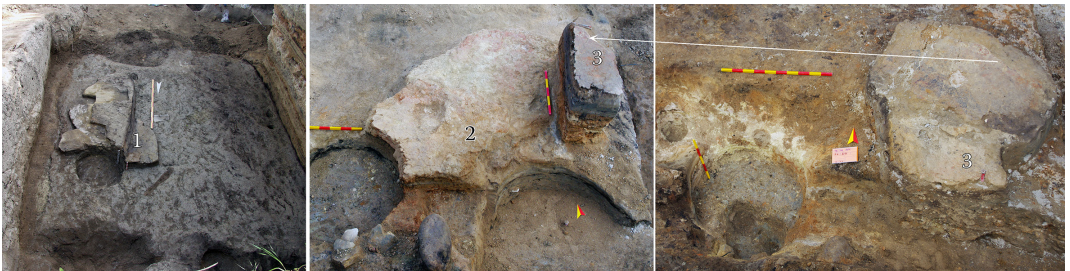
*Figure 32. Evidence of first floor fireplaces: (1) feature 72, 2004; (2) feature 67, 2014; (3) feature 50, 2014. Note topographic continuity between 2 and 3.*

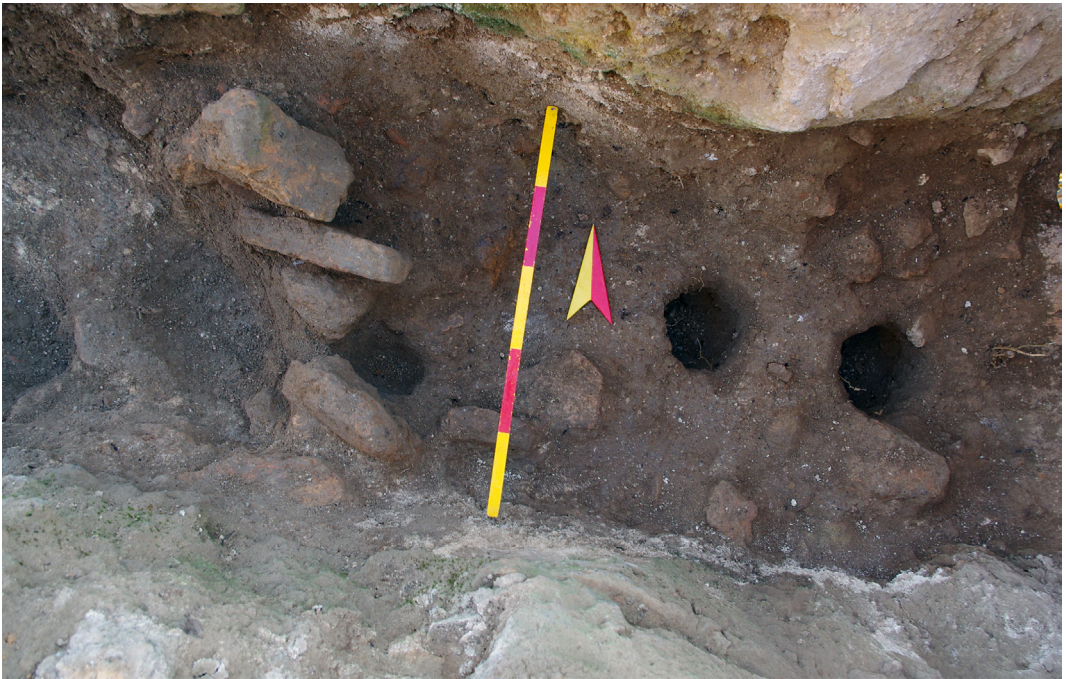
*Figure 34. Example of reuse of burnt daub as post support in a late Chalcolithic foundation trench cutting through early Chalcolithic burnt features. Feature 90 in area B, 2013.*
