# WOOD CONSTRUCTION AT THE COPPER AGE TELL SITE OF HOTNITSA, NORTH CENTRAL BULGARIA: FOUR LATE CHALCOLITHIC CASE STUDIES

Paul Bacoup<sup>1</sup>

*Between 2000 and 2017, the research project at the Copper Age tell site of Hotnitsa, located just a stone's throw from the banks of the river Bohot, uncovered several levels of occupation dated to the Late Chalcolithic. During the last two excavation seasons of 2016 and 2017, architectural remains were systematically examined, in particular the wooden floors of four buildings (horizons 4–5). A xylological study was also undertaken. The specific preservation of the material hinders identification, but new approaches could enable the timber palaeobotanical study and a better understanding of the conservation process undergone by the remains. Our main objectives were to reconstruct the chaîne opératoire involved, from the selection of the wood (species, dimensions, etc.) to the assemblies used to construct the buildings. Focusing on wooden floors, our analysis revealed three principles of floor construction based on the timber's organization and dimensions. The chaîne opératoire approach also allows for an understanding of the planning pro

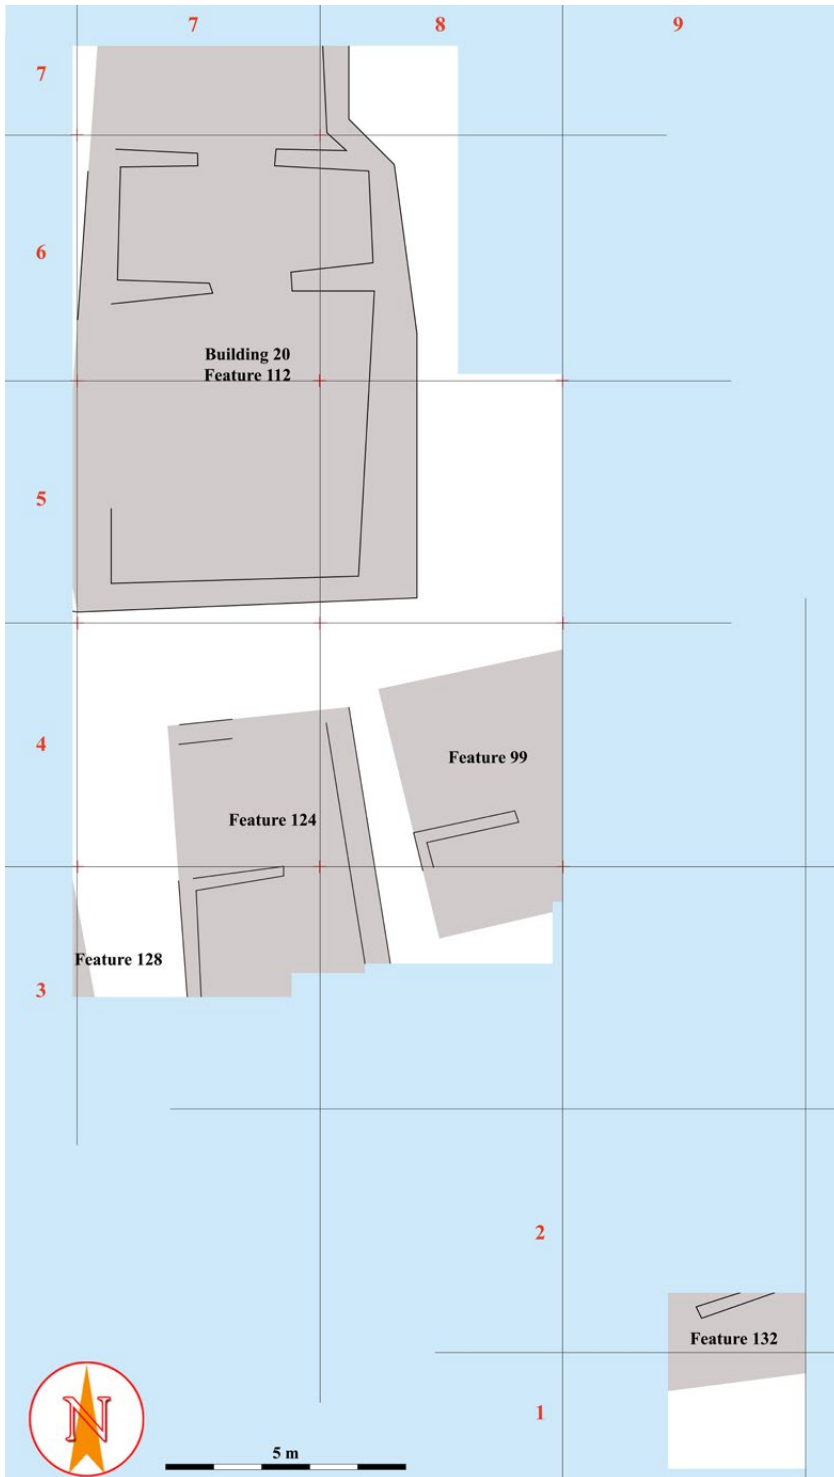
Figure 2. Layout of the excavated areas. Image Credit: A. Chohadzhiev & the author.

Two areas were studied: North and South (fig. 2). Our evidence comes from four structures: features 112, 124 and 99 in the North area, and feature 132 in the South area. These four houses belong to horizons 4 and 5, dated between 4600 and 4400 BCE, which were not destroyed by fire, and the elements made of daub<sup>1</sup> were poorly preserved; the material has disintegrated, and the structures were badly damaged and difficult to study. As for the wood, it was preserved in an unusual form, which will be discussed below.

From the point of view of the layout of the site, the structural study provides few answers, as the plans of the buildings have not been uncovered in their entirety (fig. 2). Features 99, 124 and 128 (unexcavated) are three small parallel buildings whose walls may have been very close to each other, as is known for horizon I of the site (Chohadzhiev & Chohadzhiev forthcoming). Concerning building 20, its north room was very probably not built during the first phase of the building's life. The east wall was slightly offset to the west, a potential indication of a nearby building in the unexcavated area.

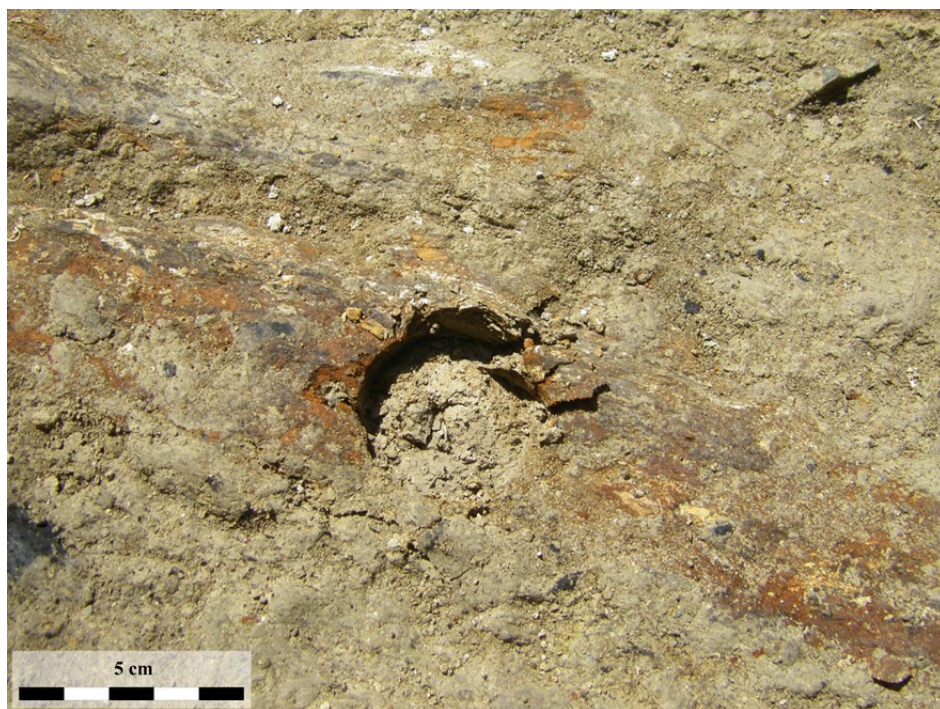
Figure 3. Thickness of the wood layer after a sampling with a die-cutter. Image Credit: the author.

Timbers preserved at Hotnitsa were close to a layer of agglomerated wood particles 1 to 5 mm thick (fig. 3). These wood residues formed a thin, relatively continuous layer over the impressions left by the pieces of wood in the sediment.

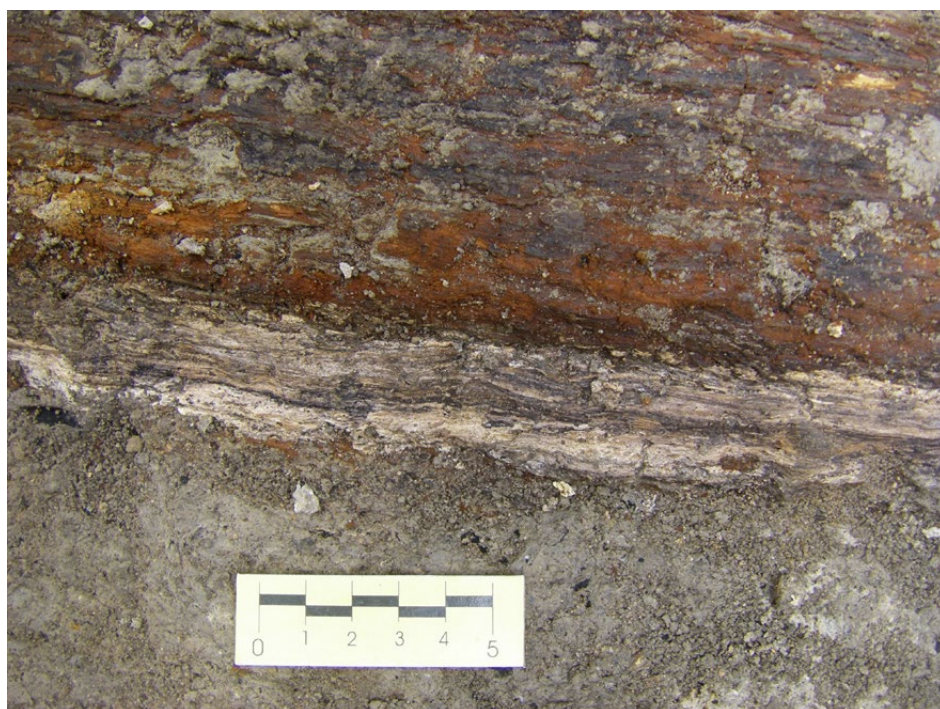
Figure 4. Halflog showing both types of wood remains. Image Credit: the author.

Taking the example of a squared piece of timber, 092-027,<sup>1</sup> it would have been cut entirely from heartwood as it consisted only of lighter material (fig. 5). On the half-logs used for wooden floors, both types of preservation could be observed. The brown material was located above the lighter one, which might suggest that these pieces of wood had a flat surface (mainly composed of heartwood) facing downwards, while their bark/sapwood was facing upwards (fig. 4).

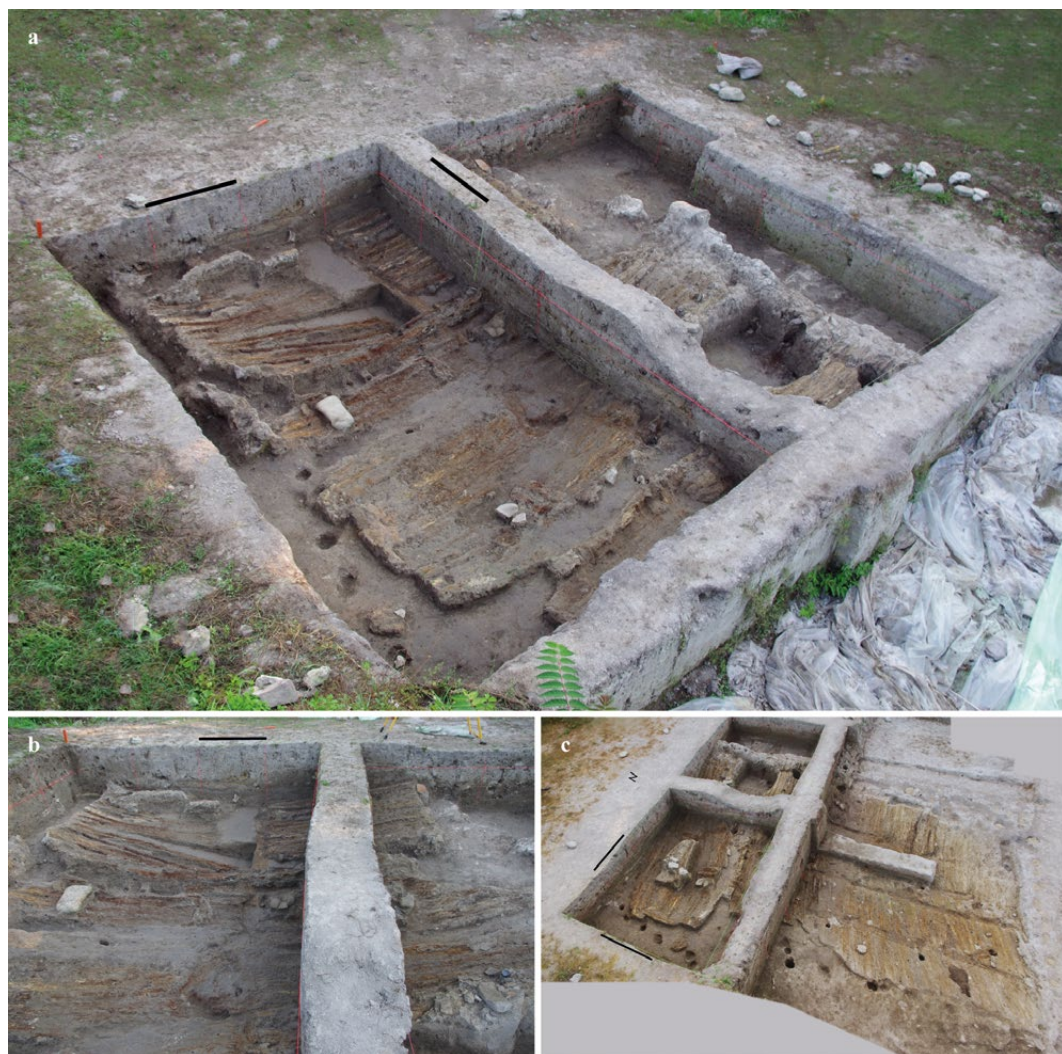
**Figure 7.** *Different views of building 20: (a) view to the northeast of the north half of the building; (b) view to the north of the north half of the building; (c) view to the northeast of the building at the end of the 2016 season. Black lines = 1 m. Image Credit: A. Chohadzhiev.*

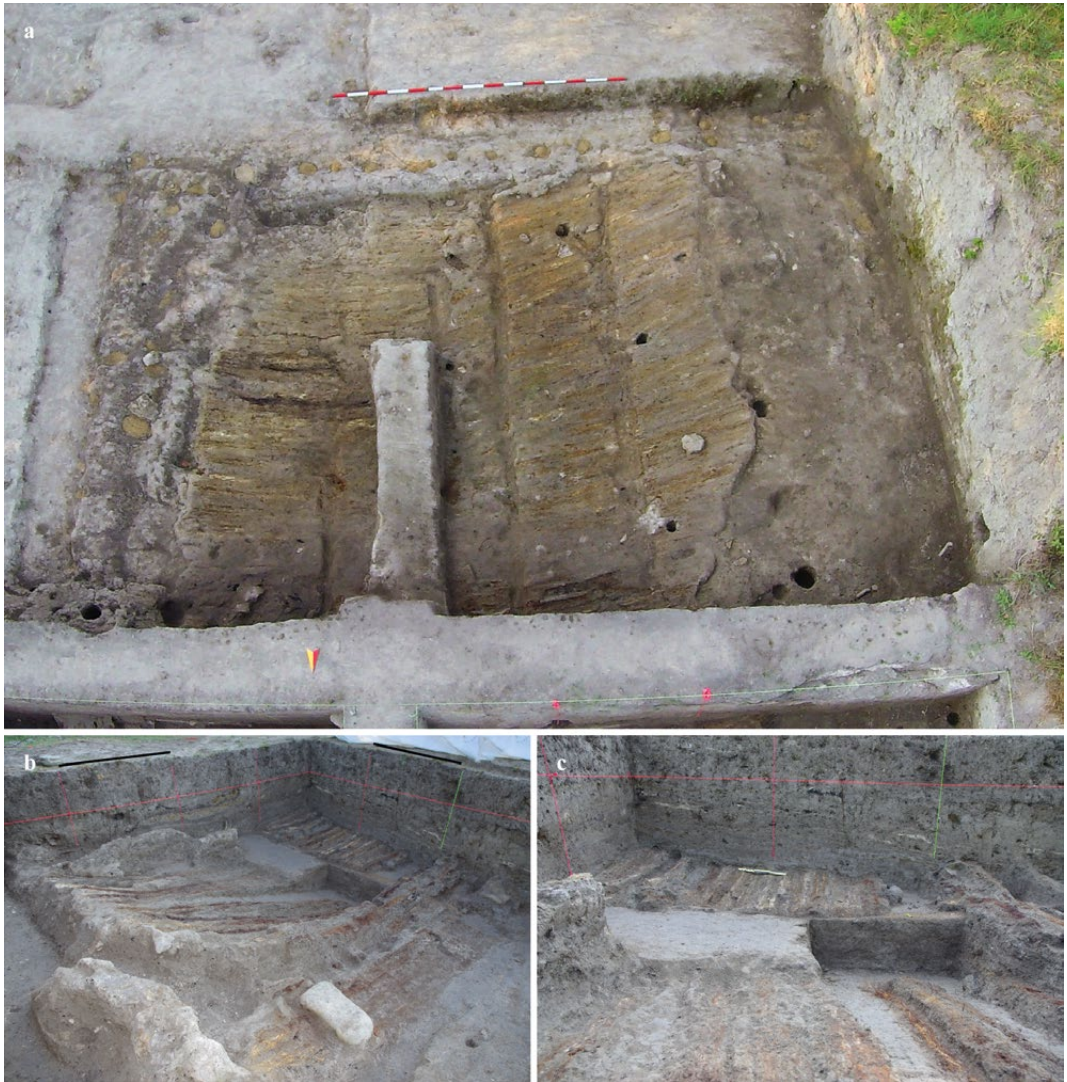
**Figure 8.** *Different views of building 20: (a) view to the south of the south part of the building; (b) view to the northeast of the northwest part of the building; note that the planks have fallen under the joist; (c) floor-level view to the east of the northwest side of the building. Black line = 1 m. Image Credit: A. Chohadzhiev.*

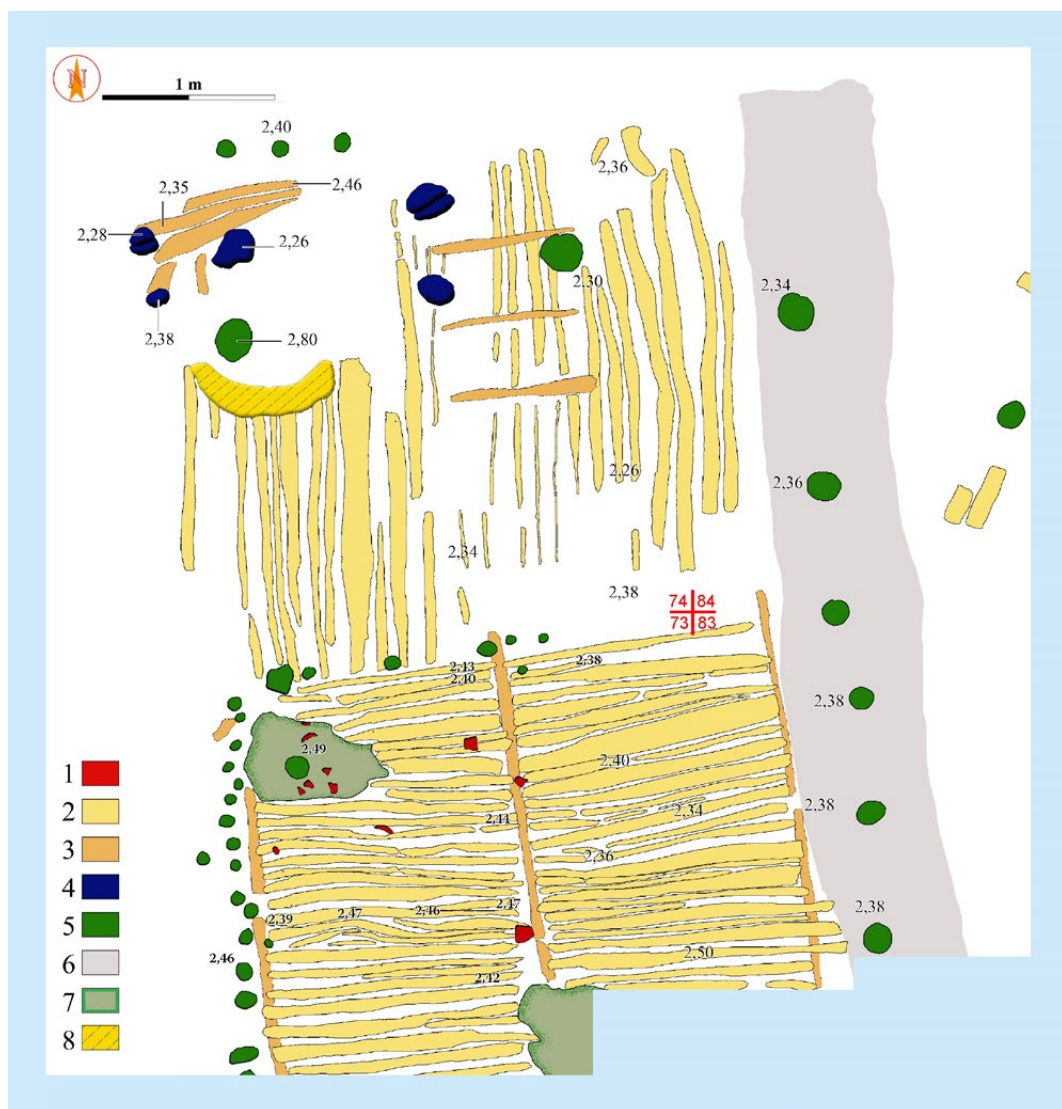
**Figure 12.** *Layout of feature 124. Key: (1) ceramics; (2) floorboard; (3) joist; (4) rock; (5) post-hole; (6) foundation trench; (7) cut; (8) clay installation. Image Credit: A. Chohadzhiev.*

Feature 124 is located in the southern part of the North area (squares 73 and 74) and corresponds to the wooden floor of a building that was approximately 3 m wide on the inside. Its total length is not known as the building continues further south, out of the excavation area, but it was at least 6 m long (fig. 12). The building is oriented north-south, with a slight northwest-southeast deviation. There are two main orientations of the floor's wood pieces: east-west in the south half of the building and north-south in the north half (figs. 12 and 13). A west-east line of postholes separates the two floors starting from the west wall and running in the western two-thirds of the room. The foundation trench of the east wall was uncovered measuring 60 to 70 cm thick. It was not excavated. The north wall of the building was marked by three postholes aligned east-west. The west wall of the building was made of daub on a wooden frame; it was 20 to 30 cm thick and was preserved between 15 and 18 cm high, with numerous post imprints (fig. 13; Chohadzhiev et al. 2014, 85; Chohadzhiev & Chohadzhiev 2017, 95f).

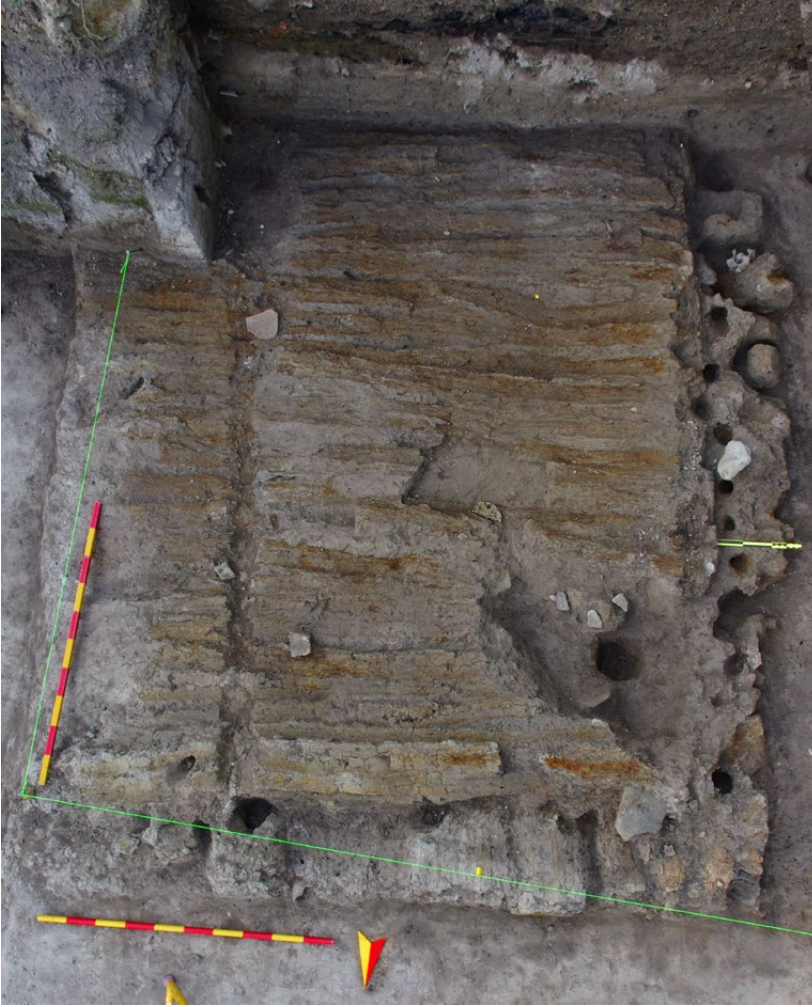
**Figure 13.** *View from above of the south floor of feature 124 excavated in 2016. Image Credit: A. Chohadzhiev.*

The floor in the south room was made of boards running east-west almost side by side, with widths ranging from 2.3 to 16.5 cm (average: 6.2 cm; see fig. 22 below). Same as in building 20, it is difficult to determine the original diameter of the logs used to make

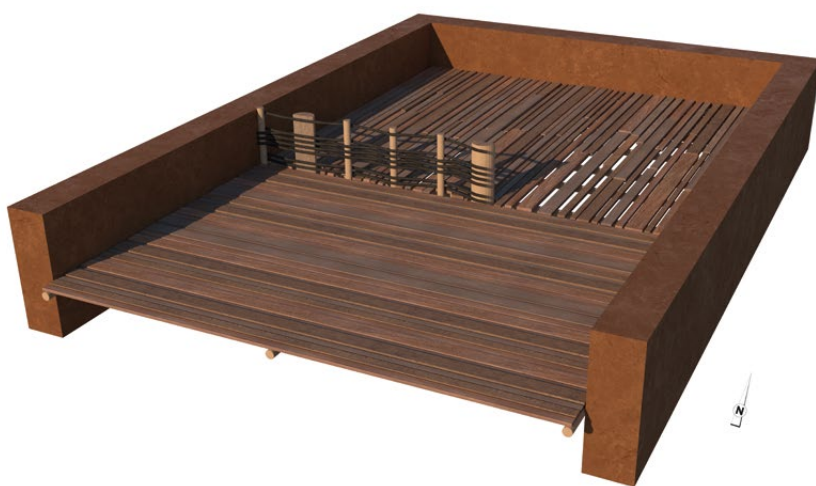
Figure 14. 3D model of the lower part of the building whose floor is labeled as feature 124.

The evidence is too fragmentary to enable the reconstruction of the building's entrance. The partition wall between the rooms could have not been daubed; a simple wooden (wattle?) partition wall could have been used to separate the spaces. Finally, the entry between the rooms was located at the east wall (fig. 14).

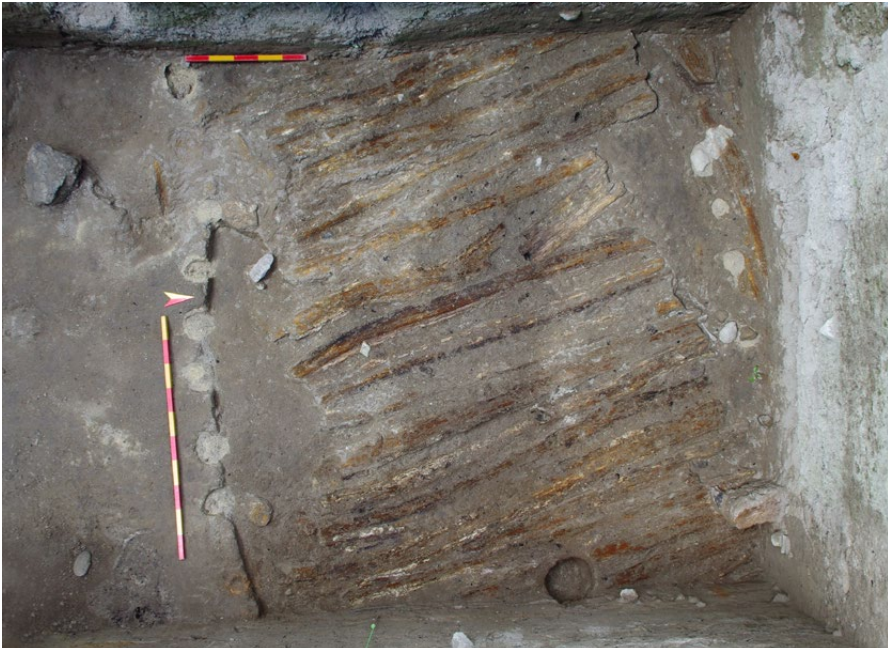
**Figure 18.** *View from above of feature 132. Image Credit: A. Chohadzhiev.*

Feature 132 is located in squares 91 and 92 of the South area (figs. 17 and 18). Most of the wood pieces there were the remains of a floor which extended further west and

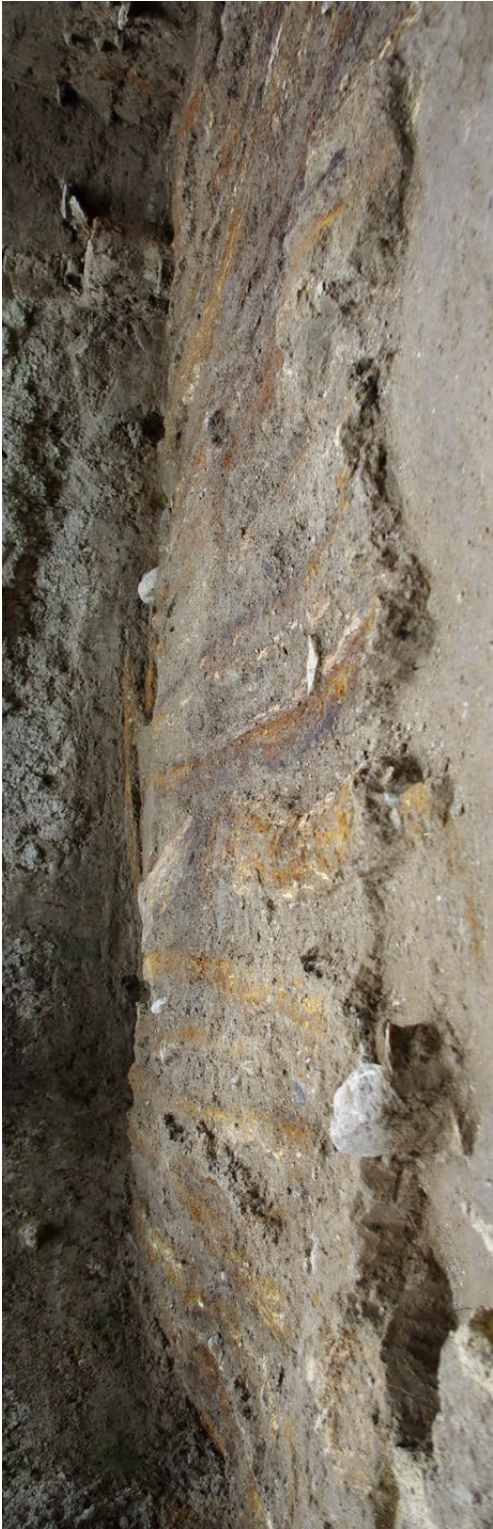
**Figure 19.** Floor-level view (to the north) of feature 132. Note the half-round shape of the logs. Width of the trench 3 m. Image Credit: A. Chobadzhiev.

The central part of the feature was occupied by a floor whose boards were oriented southeast-northwest. These were half-round logs lying on their flat sides (fig. 19). Their diameter varies between 4.5 cm and 15 cm (9.1 cm on average). The upper sides of some of them showed traces of work with a stone adze or axe (fig. 20). These marks indicate that the height of the boards making up the floor was adjusted to produce a flat surface, and/or that the logs were delimbed.

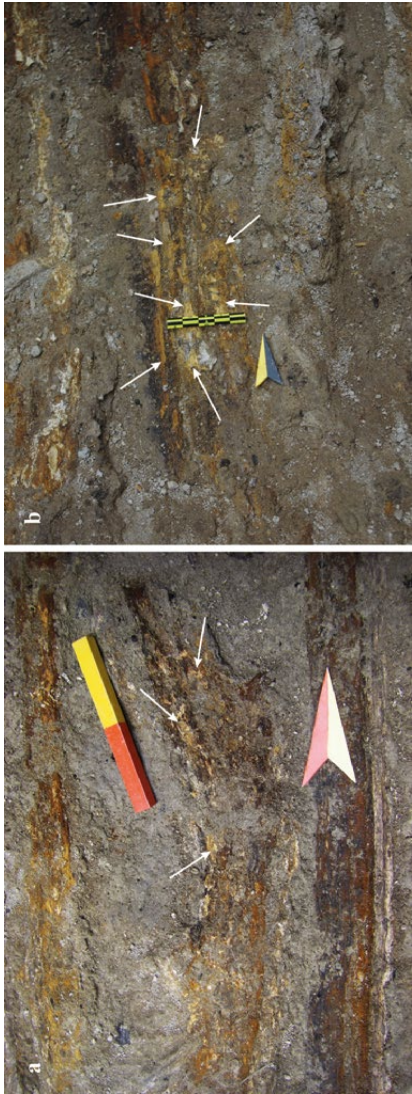
**Figure 20.** Wood pieces bearing work traces, probably from ground stone tools (marked with white arrows). Image Credit: A. Chobadzhiev & the author.

Last, this study enabled us to identify a variety of traces of woodworking within the same feature. Indeed, several pieces clearly bear traces of squaring. Stone adzes or axes have probably been used for delimbing or levelling half-round logs as also for squaring. There is also evidence of the shaping of a tenon and several mortises, indicating mostly the use of chisels (bone or stone). Finally, there is evidence of splitting to shape floor pieces.

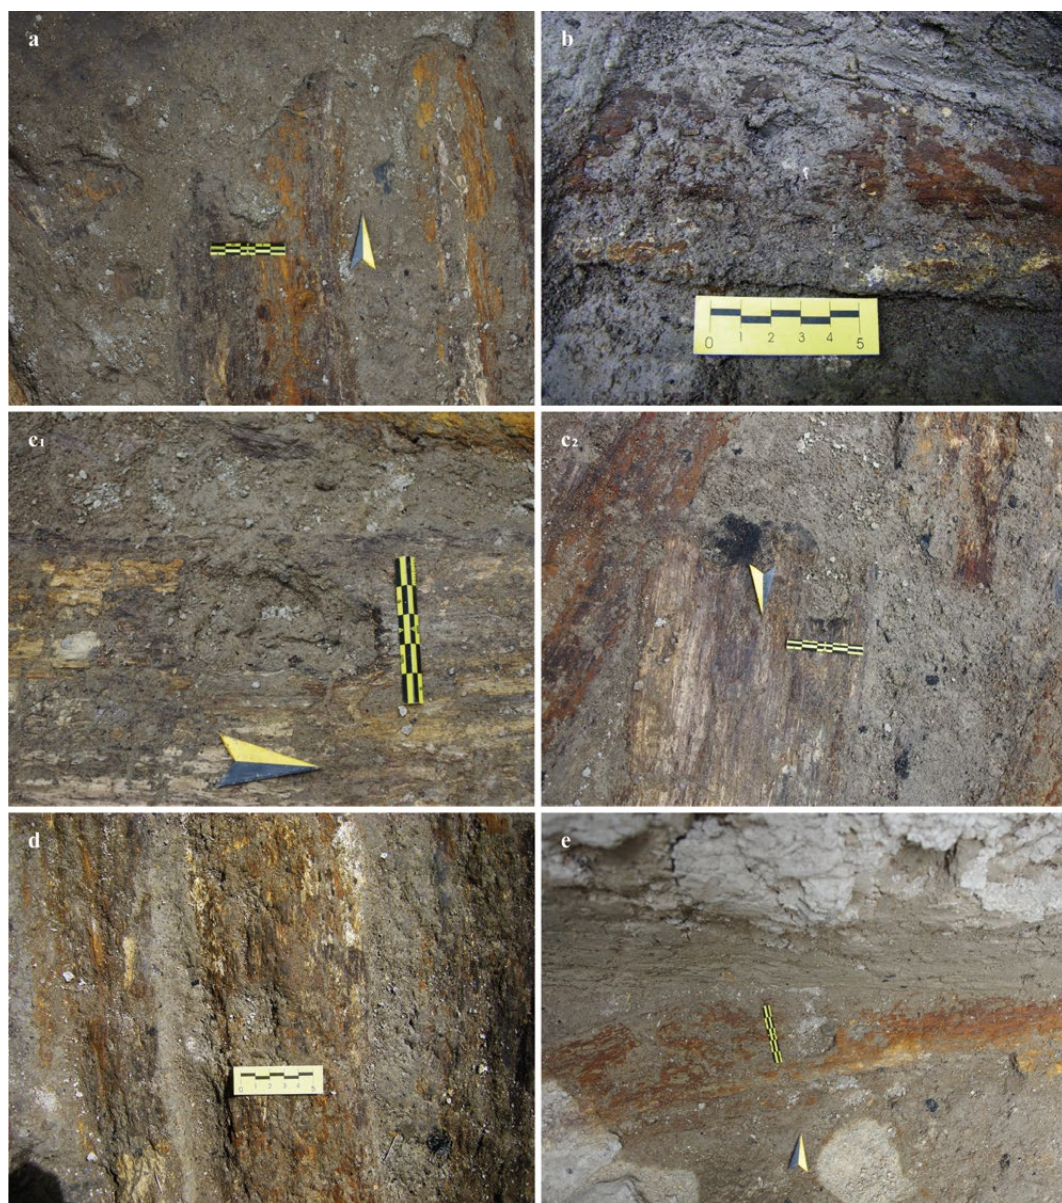
**Figure 21.** *Mortises identified in feature 132: (a) circular mortise MT-003; (b) circular mortise MT-005; (c) quadrangular mortises MT-002a (c1) and MT-002b (c2) on the wood piece 092-027; (d) quadrangular mortise MT-004; (e) quadrangular mortise MT-001. Image Credit: A. Chohadzhiev & the author.*

As soon as the feature was excavated, several holes were identified in the timbers. Some of them, particularly those found in the floorboards, could be linked to the disappearance (decayed or simply come off) of dead knots. At the same time, six other holes appear to have been mortises: two circular and four quadrangular. The first circular mortise has a regular shape and measures 4 cm in diameter (MT-003; fig. 21a). The second has a more irregular outline and a diameter of 3 cm (MT-005; fig. 21b). The quadrangular mortises are quite distinct. Two have similar dimensions: 5 by 3 cm and 6 by 3.5 cm (MT-002a and b; fig. 21c1 and c2). The other two are smaller: 3.5 by 2.3 cm (MT-004; fig. 21d) and 4 by 3 cm (MT-001; fig. 21e).
